CARR-1460
McGee Farm
Carrollton (vicinity)

Maryland Historical Trust State Historic Sites Inventory Form

historic McGee Farm

Survey No. CARR-1460

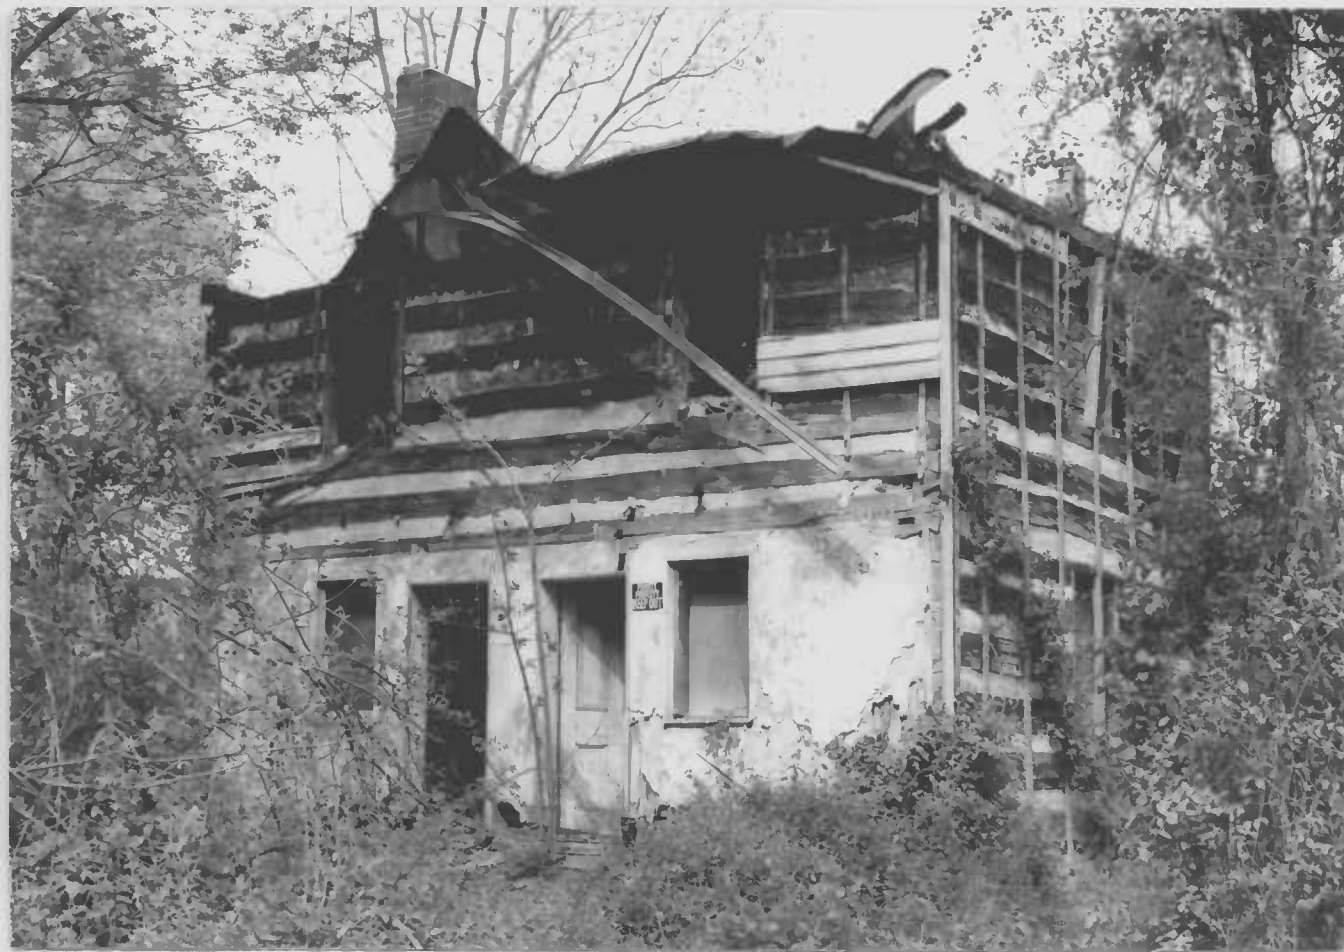
1/2

Neg. Loc.: Maryland Historical Trust
house - W. & S. elevs.

The north elevation has clapboard on vertical nailers and corner boards. There are no openings. The south elevation has vertical nailers and one central window opening on both the first and second stories. This opening is at least partially blocked by the brick chimney,

which must be a later addition. The east elevation was not entirely accessible, but appears to have a window in the south bay and a door in the north bay on the first story. There is no evidence of an interior log wall partition.

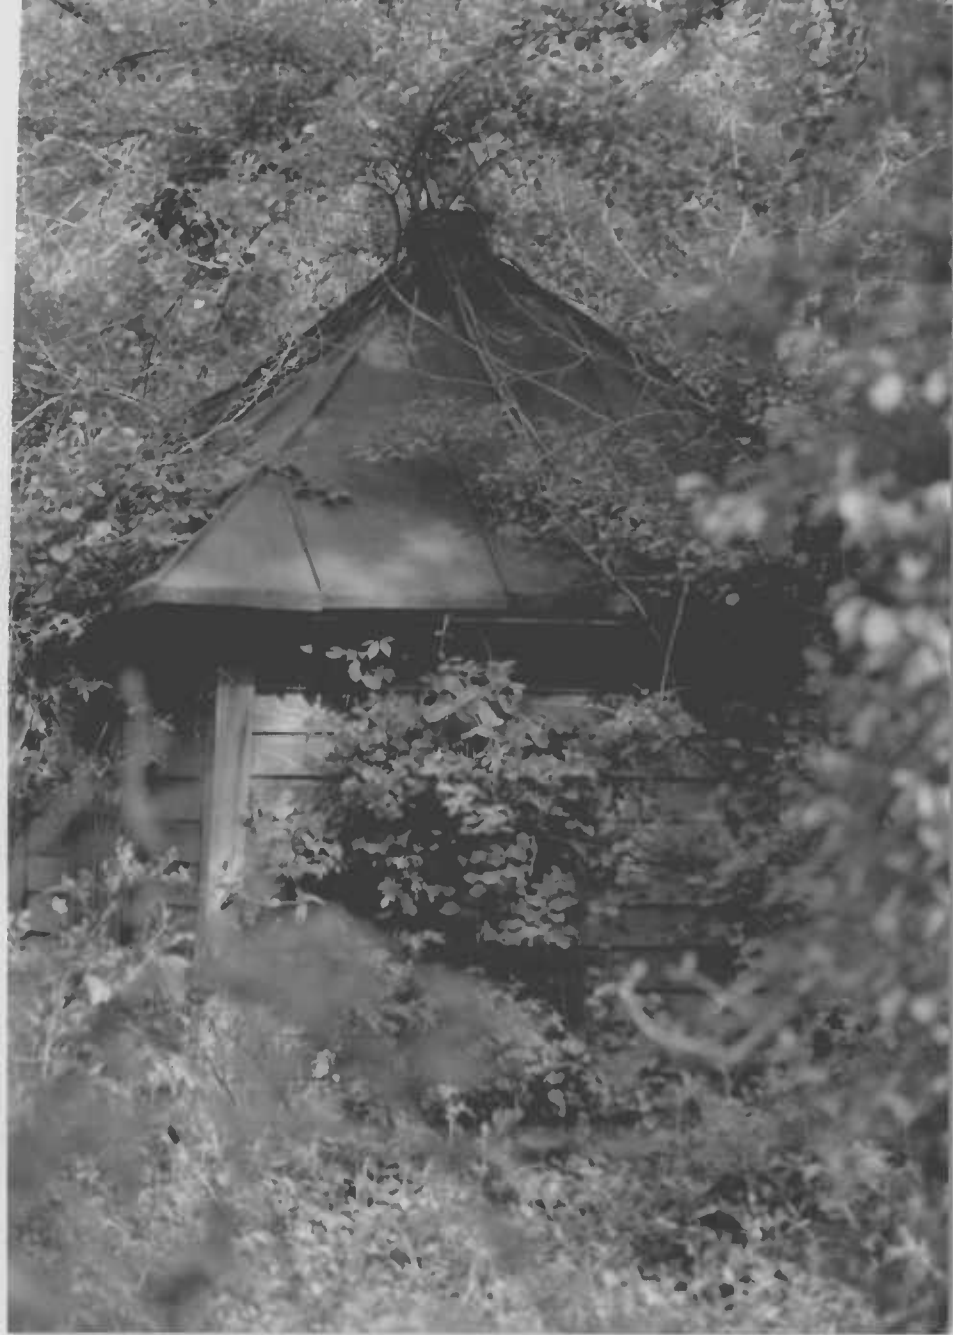
2/2

Neg. Loc.: Maryland Historical Trust
Smokehouse - N. & W. elevs.

About 20 feet south of the house is a smokehouse. It is a one-story, one-bay square clapboard structure with corner boards and a hip roof of standing-seam metal. It appears that the peak of the hip has a wood box. There is a door on the north elevation.
